Quality Assurance and Source Inspection

Contract #: 04-0120F4Cty: SF/ALA Rte: 80 PM: 13.2/13.9File #: 69.28**WELDING INSPECTION REPORT****Resident Engineer:**Pursell, Gary**Address:** 333 Burma Road**City:** Oakland, CA 94607**Report No:** WIR-007530**Date Inspected:** 21-Jun-2009**Project Name:** SAS Superstructure**OSM Arrival Time:** 700**Prime Contractor:** American Bridge/Fluor Enterprises, a JV**OSM Departure Time:** 1900**Contractor:** Zhenhua Port Machinery Company, Ltd (ZPMC), Changxing Island **Location:** Shanghai, China**CWI Name:** Xu Le Feng, Yu Dong Ping**CWI Present:** Yes No**Inspected CWI report:** Yes No N/A**Rod Oven in Use:** Yes No N/A**Electrode to specification:** Yes No N/A**Weld Procedures Followed:** Yes No N/A**Qualified Welders:** Yes No N/A**Verified Joint Fit-up:** Yes No N/A**Approved Drawings:** Yes No N/A**Approved WPS:** Yes No N/A**Delayed / Cancelled:** Yes No N/A**Bridge No:** 34-0006**Component:** TOWER**Summary of Items Observed:**

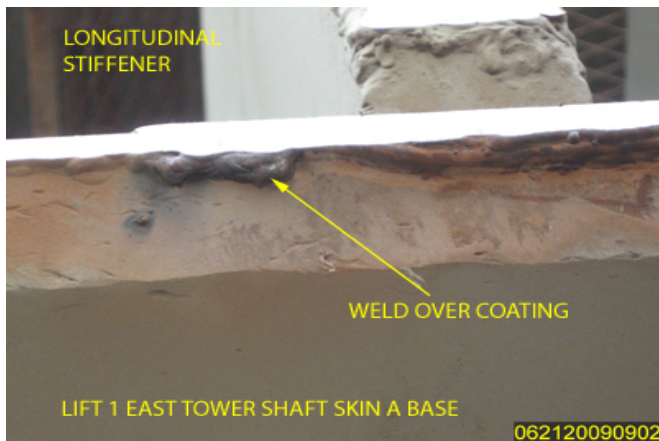
The QA Inspector randomly observed that no contract work was being performed in the interiors or on the exteriors of Lift 1 East Tower Shaft, Lift 2 East Tower Shaft or Lift 2 South Tower Shaft. The QA Inspector also randomly observed that welding had been performed over the coating in several areas on the base of Lift 1 East Tower Shaft. The attached photograph provides additional detail. The QA Inspector generated an Incident Report (TL-15) for the welding over the coating.
